## EXPERIMENTAL STUDY ON IN-PLANE AND OUT-OF-PLANE BEHAVIOR OF PP-BAND RETROFITTED MASONRY WALLETTTE MADE OF SHAPELESS STONES

**Kotaro Sakurai<sup>1)</sup>, Navaratnarajah Sathiparan<sup>2)</sup>, and Kimiro Meguro<sup>3)</sup>**

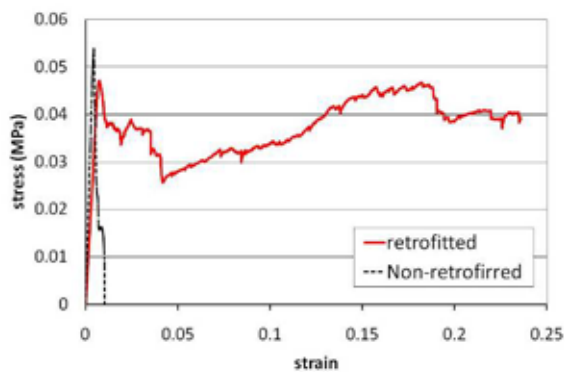
Figure 5 Stress vs. Strain for Stone Masonry Walette with and without Retrofitting by PP-band Mesh

Figure 5 shows the diagonal shear stress variation with strain for the non-retrofitted and retrofitted specimens. In the non-retrofitted case, there was no residual strength after the first crack occurred and the specimens split into two pieces at strain equal to 1.1%. If we consider average behavior of

retrofitted specimens, although the initial crack was followed by a sharp drop, at least 64% of the peak stress remained. As the matter of fact, 3 specimens were used for each non-retrofitted and retrofitted case. Subsequent drops were associated with new cracks such as the ones observed in the retrofitted specimen that shown in figure 5, at the strain of 2.5%. After this, the stress was regained by readjusting and packing by PP-band mesh. The stress equal to 72% and 81% of the initial peak stress was remained at the strain equal to 10% and 20%, respectively. The residual peak stress of the specimen was 99% of initial peak stress. If we consider the overall behavior of retrofitted specimens, specimen didn't break at the strain equal to 24%, which indicates that retrofitted specimen was at least 21 times more ductile than non-retrofitted one.

- 1) Masonry wallette without PP-band mesh lost the entire load bearing capacity after crack appeared.
- 2) Masonry wallette with PP-band mesh retrofitting lost some of load bearing capacity immediately after the crack-initiation, but 64% of the peak stress was remained. With the effects of the PP-band meshes, it could regain the load bearing capacity, and its strength and deformability improved. According to the experimental result, 1.3 times higher peak stress and at least 21 times larger ductility were observed.
- 3) By overlaying mortar onto PP-band mesh retrofitted masonry wallette, 77% of the peak stress was remained after the first crack. It was higher than that of the specimens without surface finishing.

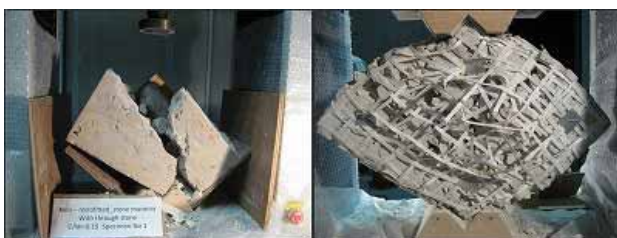
Figure 6 Failure Pattern of Stone Masonry Walette (Left: without Retrofitting, Right: with Retrofitting)

Figure 6 shows the non-retrofitted and retrofitted specimens at the end of test, which corresponded to the strain equal to 1.1% and 24%, respectively. As strain became larger, due to very low mortar strength, PP-band penetrated to the specimens. Therefore, increase of strength was not observed with strain. However, for specimens used for 1/4 scaled experiment, scaled PP-band whose width was approximately 6mm was used and it increased penetration-rate. But in case of full-scale structure, because 15mm PP-bands are used, penetration of PP-band meshes to the masonry houses are reduced relatively. Therefore additional increase of strength is expected, when the real masonry structures are retrofitted by PP-band meshes.

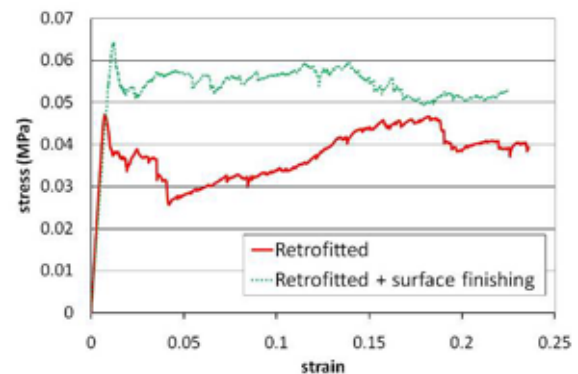
Figure 7 Stress vs. Strain for Retrofitted Stone Masonry Walette with and without Surface Finishing

Figure 7 shows the diagonal shear stress variation with strain for retrofitted specimens with and without surface

finishing. As a surface finishing, mortar with the thickness of 10mm was pasted on specimens. In case of retrofitted specimen without surface finishing, 64% of the peak stress remained after the first crack. On the other hand, if we consider average behavior of retrofitted specimens with surface finishing, 77% of the peak stress was remained after the first crack. By overlaying mortar onto PP-band mesh, surface finishing fill the gap between PP-band mesh and masonry walette and the residual strength became higher than that of the specimens without surface finishing. It was found that surface finishing makes beneficial effect in residual strength for masonry made of shapeless stones as well as for adobe and brick.

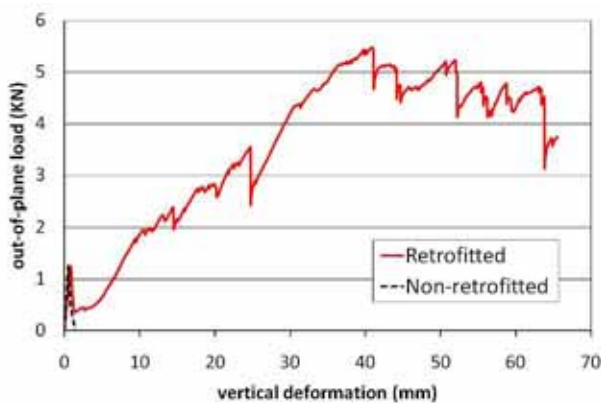
Figure 9 Out-of-plane Load Variation vs. Vertical Deformation

Figure 9 shows the out-of-plane load variation with net vertical deformation for the non-retrofitted and retrofitted specimens at the mid span. If we consider average behavior of non-retrofitted specimens, the initial strength was 1.34 KN and the specimens split into two pieces at the mid span deformation equal to 1.4mm. In the retrofitted case, although the initial crack was followed by a sharp drop, at least 33% of the peak strength remained. After this, the strength was regained progressively due to the PP-band mesh effects. In the retrofitted specimen shown in figure 9, the strength equal to 225% and 433% of the initial peak strength was observed at the mid span deformation equal to 20mm and 40mm, respectively. The residual peak strength of the specimen was 439% of initial peak strength. Specimen didn't break at the mid span deformation equal to 62mm, which indicates that; retrofitted specimen was at least 45 times more ductile than non-retrofitted one.

- 1) In case of out-of-plane tests, the mesh effect was not observed before the wall cracking. After cracking, the mesh presence positively influenced the wallette behavior. Also in case of retrofitted wallette, 33% of the peak strength was remained after the first crack occurred, and then strength was regained and improved.
- 2) The retrofitted wallettes could have 2.9 times higher strength and 45 times larger deformation than those of the non-retrofitted ones.

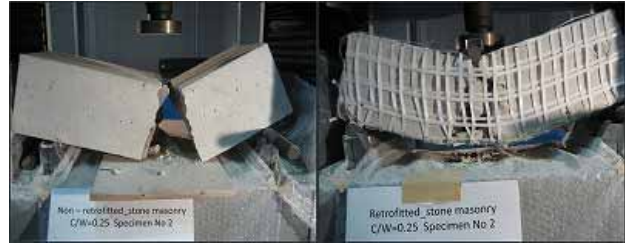
Figure 10 Failure Pattern of Stone Masonry Walette (Left: without Retrofitting, Right: with Retrofitting)

Figure 10 shows the non-retrofitted and retrofitted specimens at the end of test, which corresponded to deformation equal to 1.4mm and 62mm, respectively. In out-of-plane test, the improvement of final strength became much bigger than that of diagonal compression test. The

cement/water ratio of the specimens used for the diagonal shear test was 0.15, but in case of out-of-plane test, the cement/water ratio equal to 0.25 was used. Because strength of mortar is high enough, PP-band didn't penetrate to the specimens and the drastic improvement of residual strength was observed.
