# Shake Table Tests on One-Quarter Scale Models of Masonry Houses Retrofitted with PP-Band Mesh

This paper introduces a technically feasible and economically affordable retrofitting option for seismically vulnerable masonry structures in developing countries using polypropylene bands (PP-bands). The results of the basic material tests and shake table tests on building models show that the PP-band retrofitting technique can enhance the safety of both existing and new masonry buildings, even during severe ground motions, for instance an earthquake with a Japan Meteorological Agency (JMA) seismic intensity of 7. Therefore, the proposed method is an optimum solution for promoting safer building construction in developing countries and can contribute to earthquake disaster mitigation in the future. [DOI: 10.1193/1.3675357]

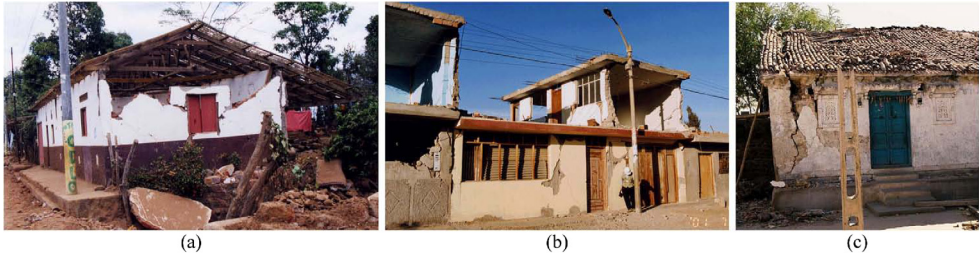
**Figure 1.** Out-of-plane failure: (a and b) collapse of masonry walls, and (c) failure of a wall connection (Mayorca 2001).

Figure 1 shows examples of out-of-plane damage in unreinforced masonry houses. This failure mode is common when the main direction of the seismic motion is perpendicular to the masonry walls and they have insufficient transversal supports. Figure 1a shows examples of structures with flexible roofs. In the first case, the roof is a wooden truss supported on two of the house walls. The other two walls do not have any support at the top and as a result the upper portions collapsed. Figure 1b shows an unreinforced masonry house with a reinforced concrete (RC) roof that is not supported by all of the walls. As a result, the walls that were not restrained by the roof collapsed. Failure of the connections between walls can

also cause out-of-plane failure, as observed in Figure 1c. Generally, the corners of any structure are associated with stress concentrations. If the connection between two walls is weak, for example due to poor-quality workmanship, it can easily fail. As a result, each of the connecting walls becomes an independent structure and is only supported at the bottom, which is a worst-case scenario during an earthquake as out-of-plane failure is very likely to occur under these circumstances.

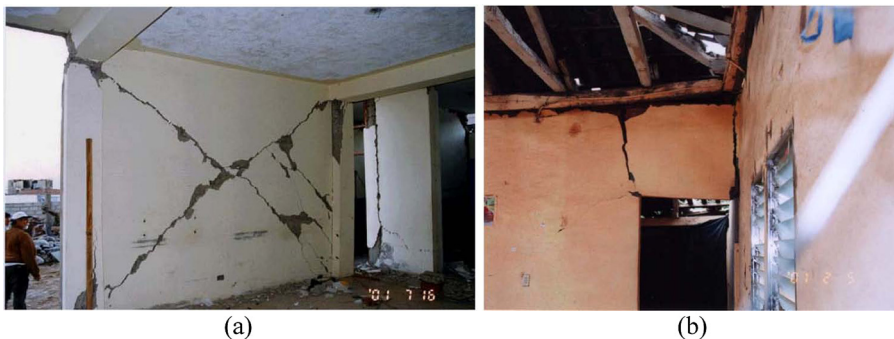
**Figure 2.** In-plane cracking of unreinforced masonry walls (Meguro et al. 2001).

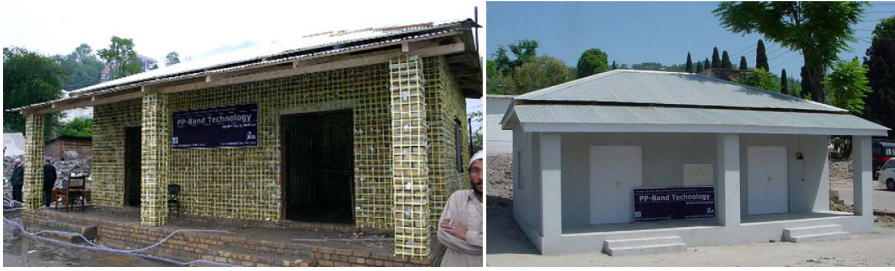
**Figure 3.** House in Pakistan retrofitted with PP-band mesh (JBIC 2007).

Assuming that the houses in need of retrofitting have two rooms of  $72 \times 27 \text{ m}^2$  (Figure 3), a retrofit using around 4,500 to 5,000 m of PP-band would cost approximately 30 USD in the Kashmir region, for example. The total cost of retrofitting depends on how much of the work done is by the house owner and how much is contracted. A cost comparison with other retrofitting materials is shown in Table 1.

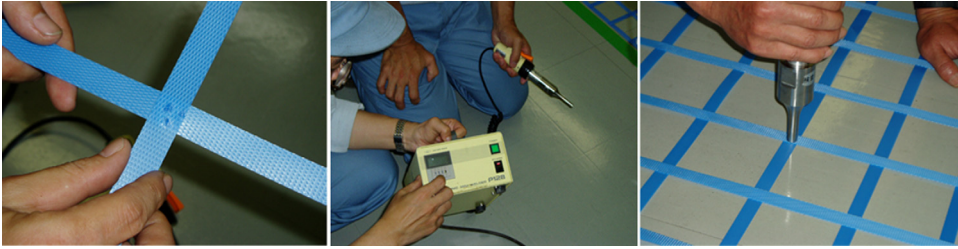
**Figure 4.** Manufacturing PP-band mesh.

An automatic manufacturing process for PP-band mesh has not yet been developed. To prepare PP-band mesh, a portable plastic welder is a necessary tool. In order to prepare the mesh, each intersection has to be welded, one by one. A plastic welder can produce an ultrasonic wave that welds plastic materials quickly, as shown in Figure 4.

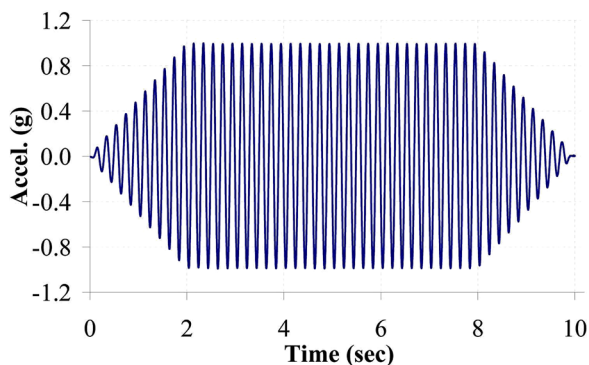
**Figure 9.** Typical shape of the applied sinusoidal wave.

Tests were carried out in a series on the shake table at the Institute of Industrial Science, University of Tokyo. Simple and easy-to-use sinusoidal motions of frequencies ranging from 2 to 35 Hz and amplitudes ranging from 0.05 to 1.4 g were applied to the specimens to obtain the dynamic response of both the retrofitted and unretrofitted structures. This simple input motion was applied because of its adequacy for later use in the numerical modeling. Figure 9 shows the typical shape of the applied sinusoidal wave input motion.

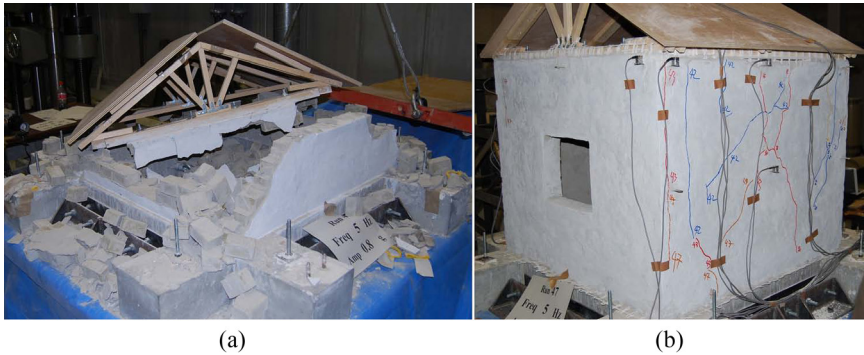
**Figure 14.** (a) The unretrofitted model, A-NR-P, and (b) the retrofitted model, A-RE-P, after Run 47.

In specimen A-NR-P, major cracks were observed close to the connection between the roof and the south wall at Run 26, and they widened with each successive run. At Run 43, during which the model had a lateral drift of 2.62 mm, a lot of damage was observed in model A-NR-P. Separation between the east wall and its adjacent walls was observed. Furthermore, a lot of the surface finish separated from the walls. At Run 44, the top corners of the east wall and the adjacent walls were totally separated from the specimen. At Run 45, the entire top part of the north and south walls totally separated from the specimen. At this point, the roof was supported by only two walls, which were perpendicular to the direction of shaking. The structure finally collapsed during Run 47. This input motion corresponded to a velocity and displacement of 250 mm/s and 8 mm, respectively. Figure 14 shows the unretrofitted and retrofitted house models at the end of Run 47.

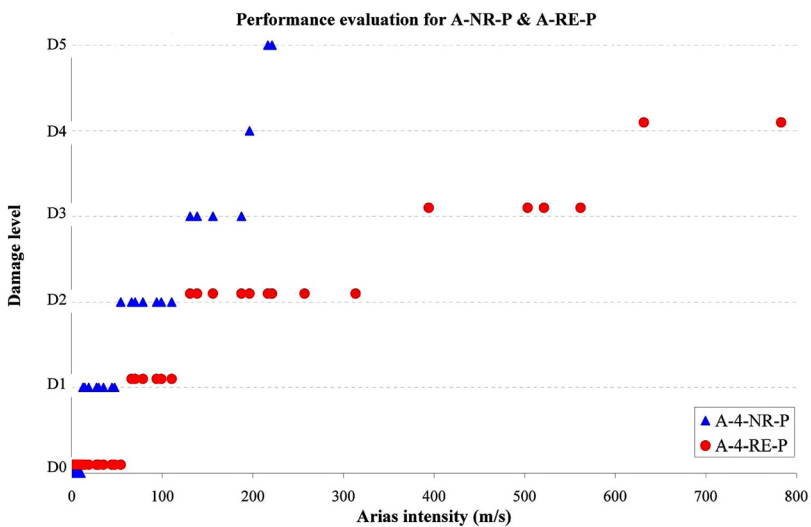
**Figure 19.** Performance evaluation based on Arias intensity for models A-NR-X and A-RE-X.

**Figure 20.** Performance evaluation based on Arias intensity for models A-NR-P and A-RE-P.

Figures 19 and 20 show the performance level of each specimen against the dynamic motion. From the results, it can be seen that the retrofitted model performed at least three times better than the unreinforced model.

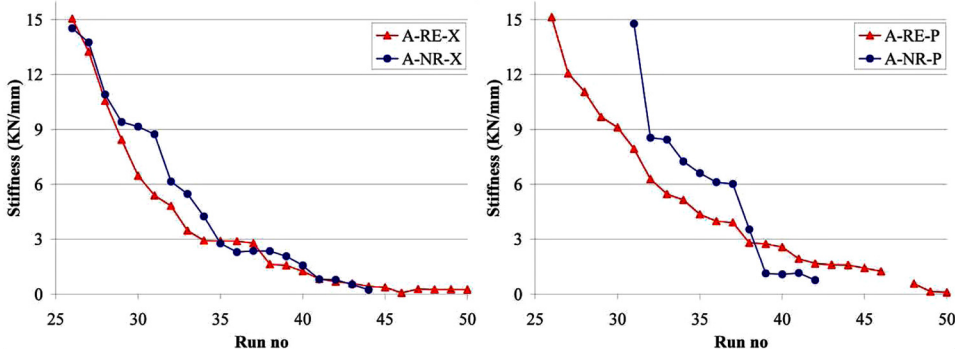
Figure 24. Stiffness degradation for each house model.

Masonry is an inelastic structural material that doesn't behave elastically, even in the range of small deformations. However, for practical reasons, the effective stiffness of a wall, defined as the slopes of the hysteresis curve (such as the graph shown in Figure 23), is determined from the ratio between lateral force and deformation in a house model. The stiffness degradation values calculated after each run are shown in Figure 24.

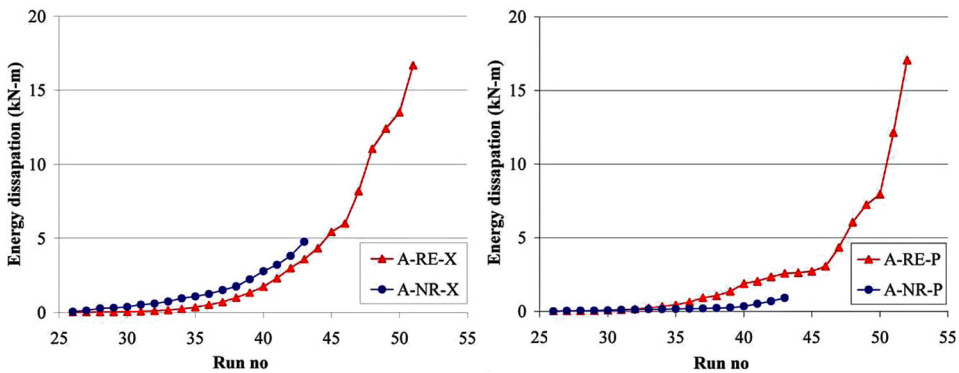
Figure 25. Energy dissipation for each house model.

dissipated in each cycle is the area enclosed by the hysteresis loop corresponding to that cycle. The energy dissipated by the whole house model corresponds to the total force and the horizontal displacement at the top of the house model.

To assess the overall performance of the structures, energy dissipation in terms of input runs is shown in Figure 25. Generally, the energy dissipation capacity of the retrofitted house specimens was much larger than that of the unretrofitted house specimens.
